WILLIAMS RUN DAM

NDI I.D. NO: 432

PHASE I INSPECTION REPORT.

11
SEPTEMBER 1978

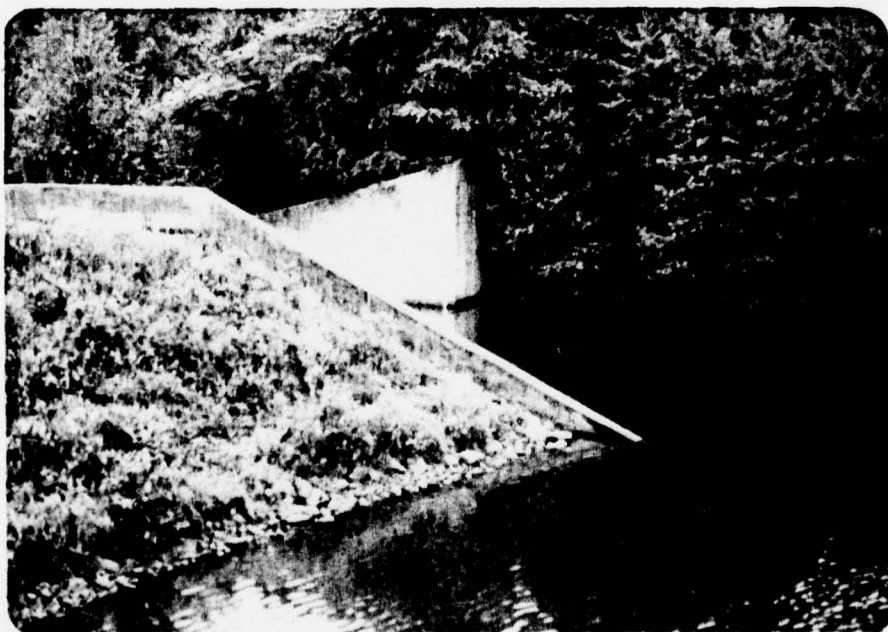
Photograph No. 2
Spillway approach channel.

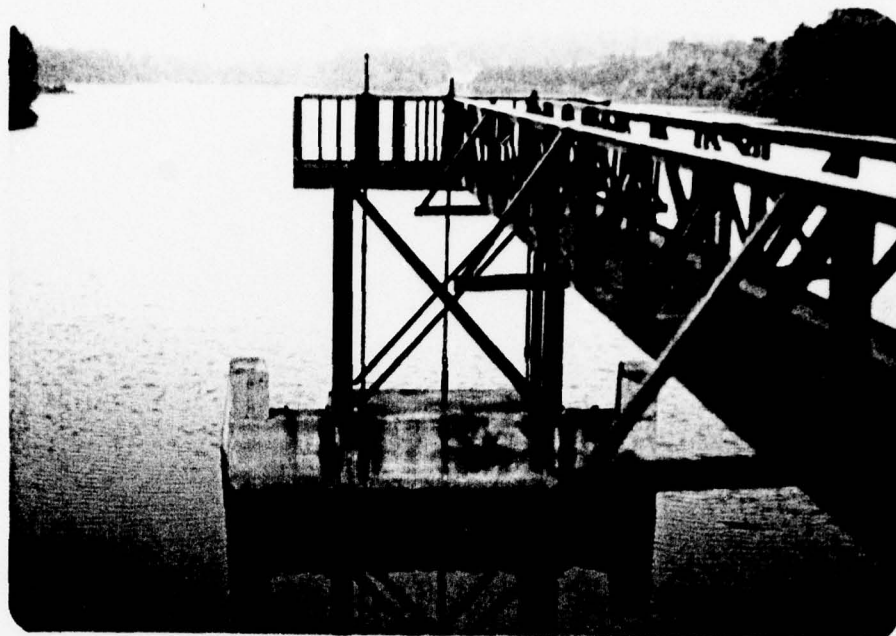
The outlet pipe valve was operated by borough personnel and observed to be functional.

Photograph No. 5
Upstream valve controls.

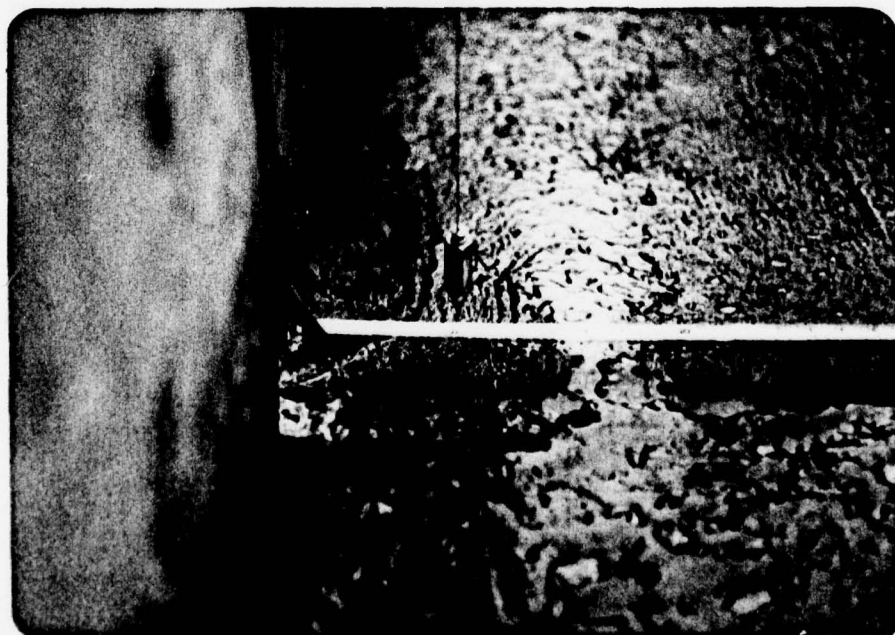
Photograph No. 6
Right spillway wall (looking downstream)
five inches out of plumb.

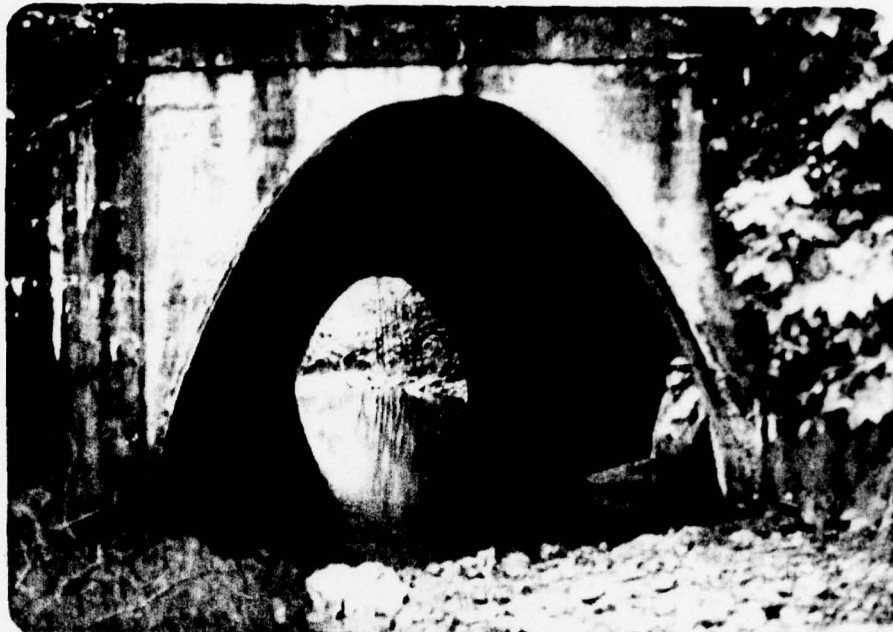
Photograph No. 7
Culvert under Route 422 (looking downstream).

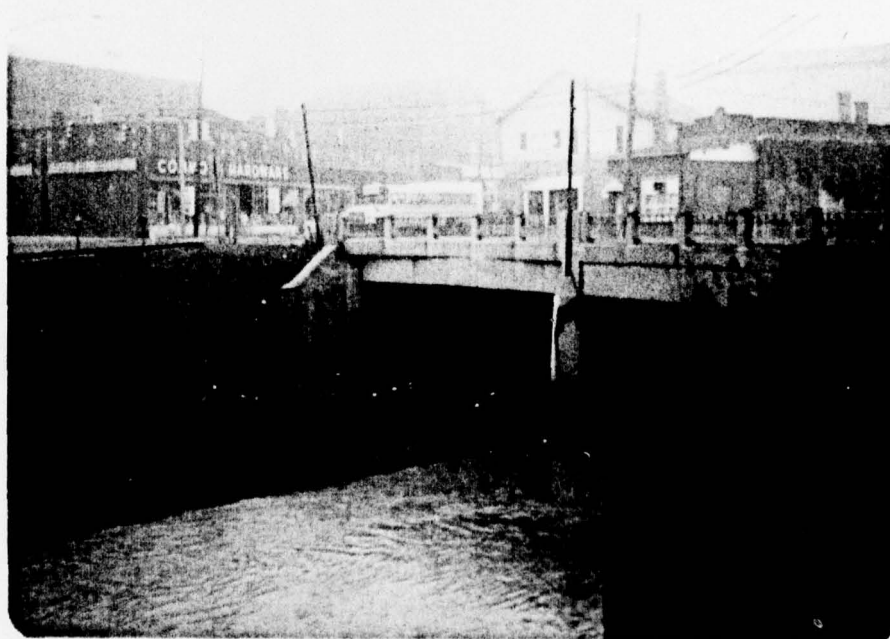
Photograph No. 8
South Branch of Black Lick Creek at
Nanty Glo (six miles downstream).
